8th International Conference on Asian and Pacific Coasts (APAC 2015)

Beach erosion downcoast of Pengambengan fishing port in western part of Bali Island

Takaaki Uda^{a,*}, Shin Onaka^b, Masumi Serizawa^c^aPublic Works Research Center, 1-6-4 Taito, Taito, Tokyo 110-0016, Japan^bNippon-Koei Co., Ltd., 5-4 Kojimachi, Chiyoda, Tokyo 102-8539, Japan^cCoastal Engineering Laboratory Co., Ltd., 1-22-301 Wakaba, Shinjuku, Tokyo 160-0011, Japan

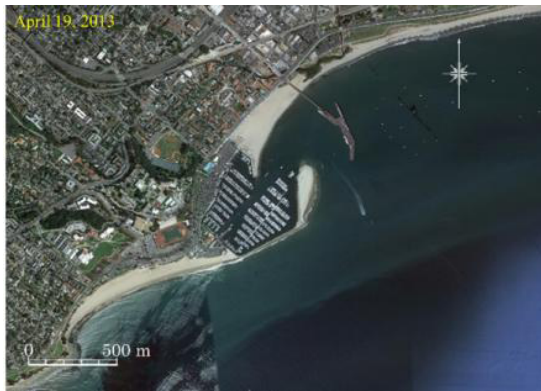
Figure 7 shows the satellite image of Santa Barbara taken on April 19, 2013. Sand bypassing is sufficiently effective that a sandy beach is maintained east of the port at present. The elongation of the sand spit is very similar to that at Pengambengan fishing port seen in the satellite image taken on May 12, 2011. Although 86 years have

Fig. 7. Satellite image of Santa Barbara, California.

passed since the construction of the port breakwater at Santa Barbara, sandy beach downcoast of the breakwater has been well maintained.

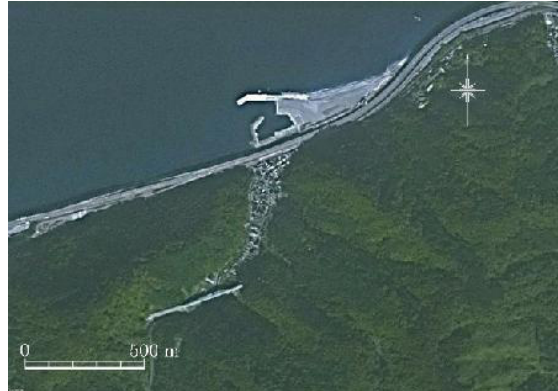
Fig. 8. Satellite image of Oyashirazu fishing port in Niigata Prefecture, Japan.

In contrast, Oyashirazu fishing port in Niigata Prefecture, Japan, is one of the examples of the devastation of the downcoast coastline. Figure 8 shows a satellite image of this fishing port, where westward longshore sand transport of $3.7 \times 10^4 \text{ m}^3/\text{yr}$ was blocked by the fishing port breakwater, and sand deposited inside the port was dredged and removed, resulting in severe erosion downcoast of the fishing port owing to the deficit of sand and resulting in the entire coastline being protected by a seawall and concrete blocks (Uda, 1997). Because protection measures such as the construction of the seawall and the installation of concrete armor units were taken along the eroded coastline downcoast of the fishing port, which gradually expanded downcoast over time, an extensive area was altered by an artificial coastline comprising the seawall and concrete armor units. The construction of this fishing port began in 1966, and full-scale construction works started in early 1970. Therefore, 43 years have passed since. Even though the rate of longshore sand transport at Oyashirazu fishing port was lower than that at Santa Barbara by one order of magnitude, the coastline downcoast of the fishing port was rapidly covered with concrete facilities, i.e., natural sandy beach was altered in an artificially protected coastline.
